MTL TR 90-61

THE BSU-86/B BOMB FIN ASSEMBLY FIRST ARTICLE CONFORMANCE TESTING

MARC S. PEPI, VICTOR K. CHAMPAGNE, Jr., and
CATHERINE M. ZOLLER
MATERIALS TESTING AND EVALUATION BRANCH

December 1990

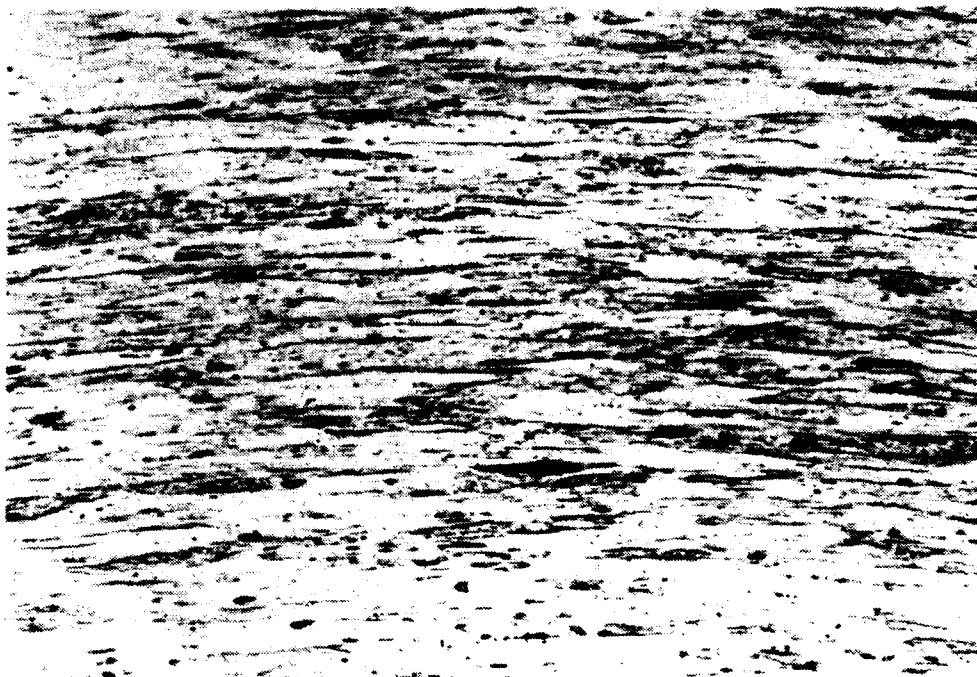
Transformation of some austenite to martensite in 302 stainless steel during forming can be observed in the micrograph. Flow lines are additional indications of processing, as specified in ASTM A313 (see Figure 37).

Figure 37. Optical micrograph of the tension spring microstructure reveals some martensite in an austenite matrix of the 302 stainless steel. MAG 200X

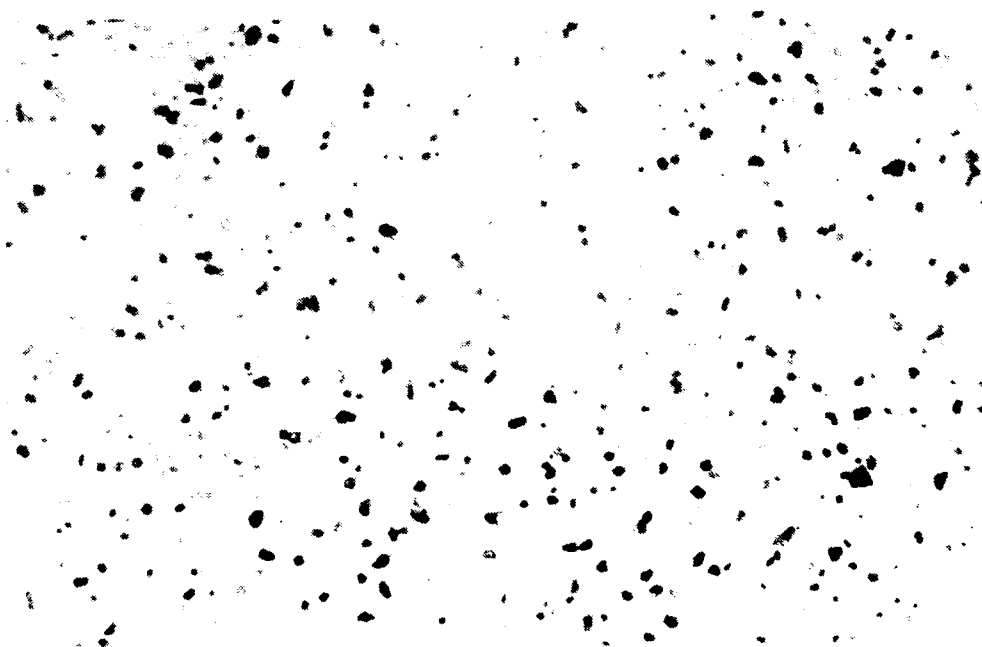
The micrograph reveals evenly dispersed precipitates, and is representative of drawn 3003 aluminum alloy, as specified in QQ-A-200/1 and WW-T-700/2 (see Figure 38).

Figure 38. Optical micrograph of the guide tube showing no abnormalities within the microstructure of the 3003 drawn aluminum alloy. MAG 500X

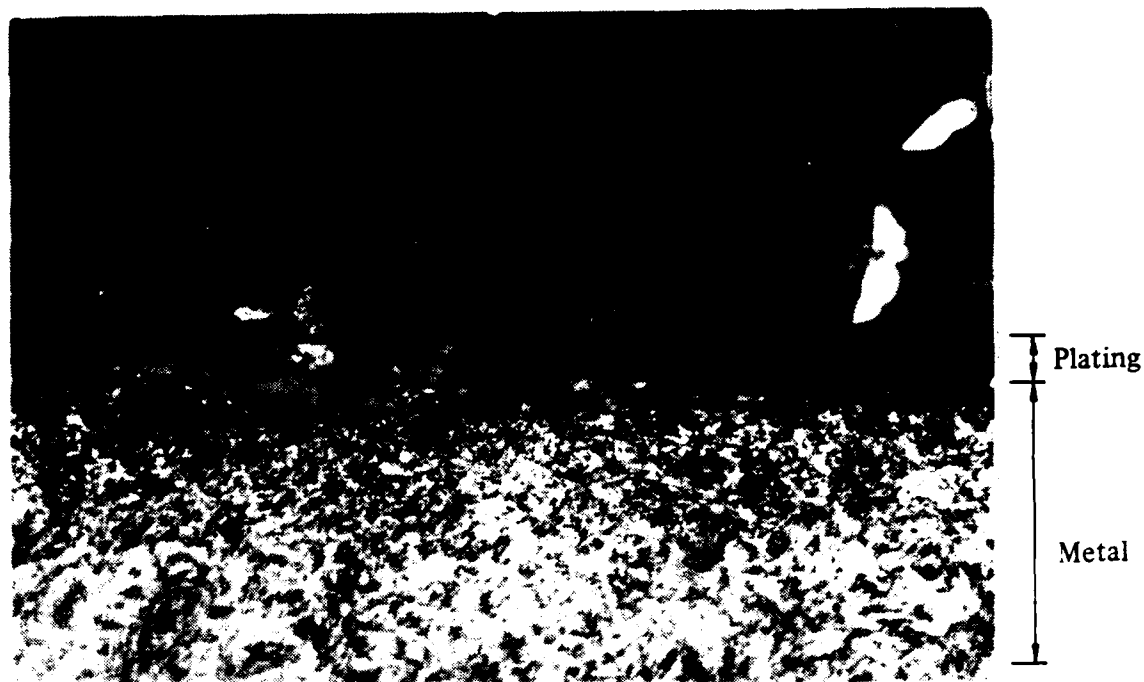
Figure 42. Optical micrograph of the setscrew revealing a plating thickness of 0.0005 inch. MAG 800X
